MEANDER LOOP MIGRATION AND LIQUEFACTION
SUSCEPTIBILITY: LIQUEFACTION ALONG THE HEATHCOTE
RIVER DURING THE 2010-11 CANTERBURY EARTHQUAKE
SEQUENCE

A thesis submitted in partial fulfilment of
the requirements for the degree of
Master of Science in Geology
at the
University of Canterbury
by
KIERAN THOMAS GRACE

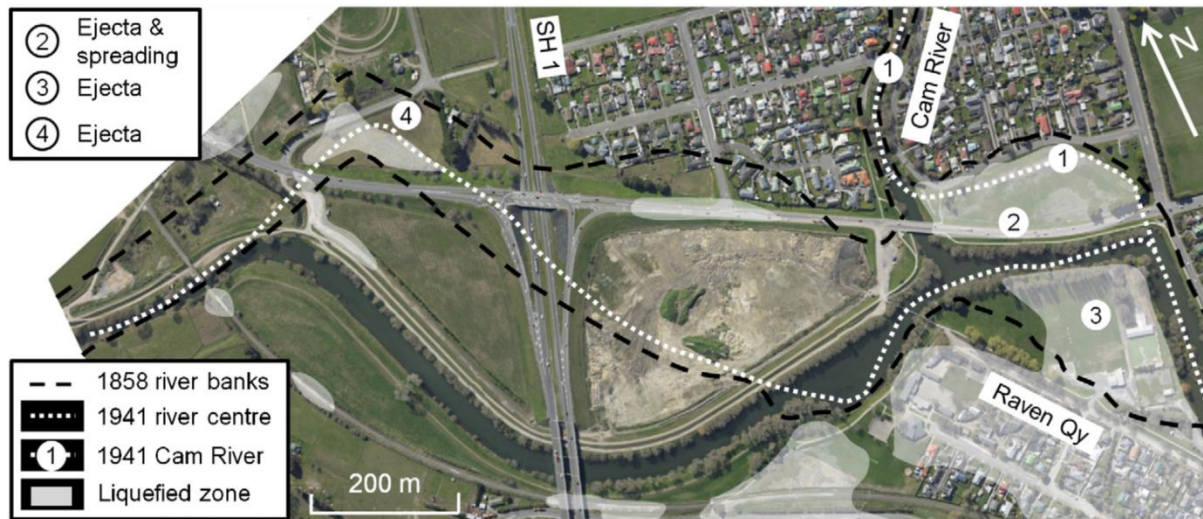
Figure 1.16: Aerial photograph of western Kaiapoi indicating the locations of the former Waimakariri River channels and liquefied zones following the M_w 7.1 Darfield earthquake. From Wotherspoon et al. (2012).

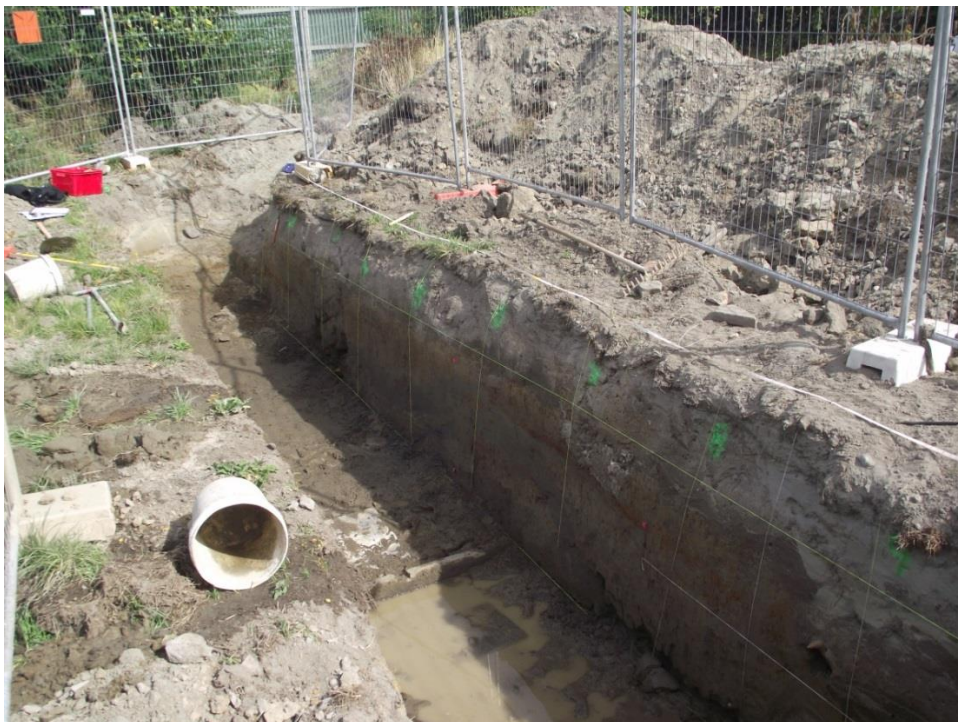
Figure 2.2: Excavated trench at Site 2 at the former residential property at 68a St Martins Road, St Martins.

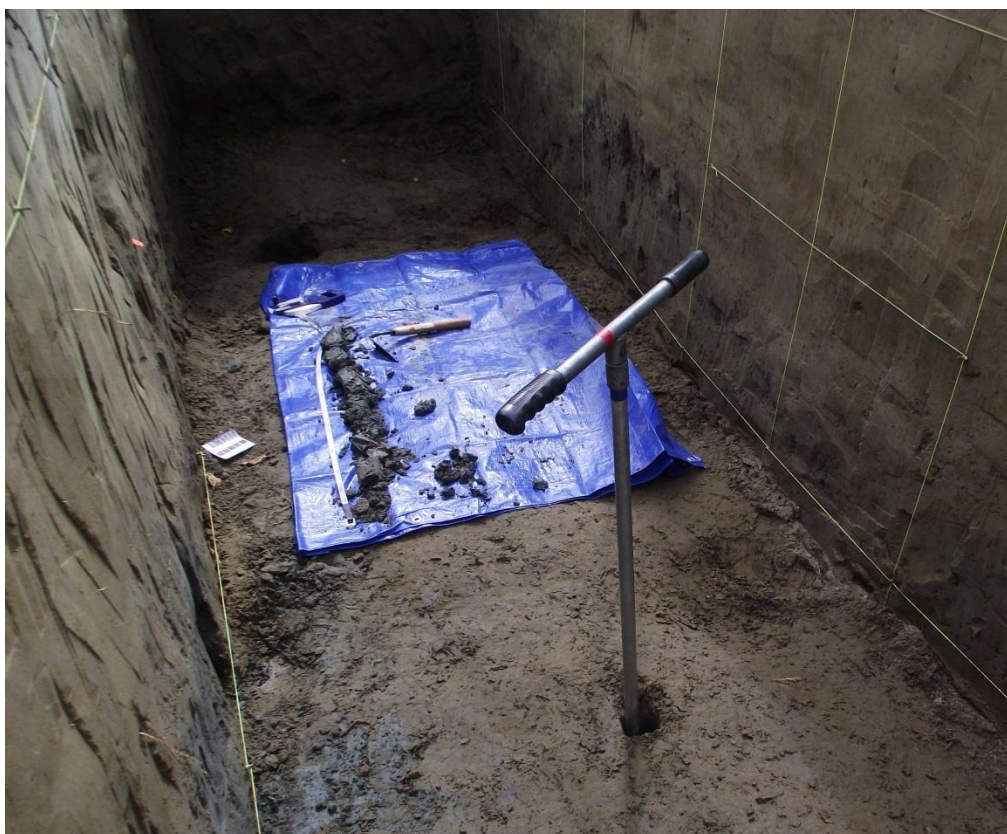
Figure 2.3: Hand auger sample collection from below the floor of the excavated trench at St Martins Park (Site 1).

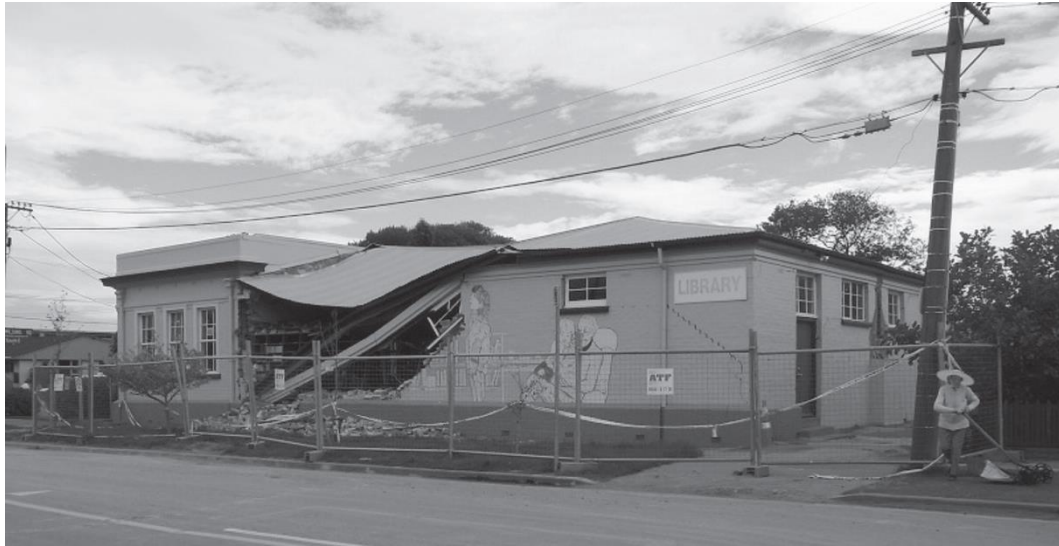
Figure: 3.10: Damage to the St Martins library following the 22 February earthquakes from intensive shaking and liquefaction-induced ground deformation causing damage to the foundation. Note the tilted power pole due to loss of soil strength in the near-subsurface. From Orense et al, (2011).

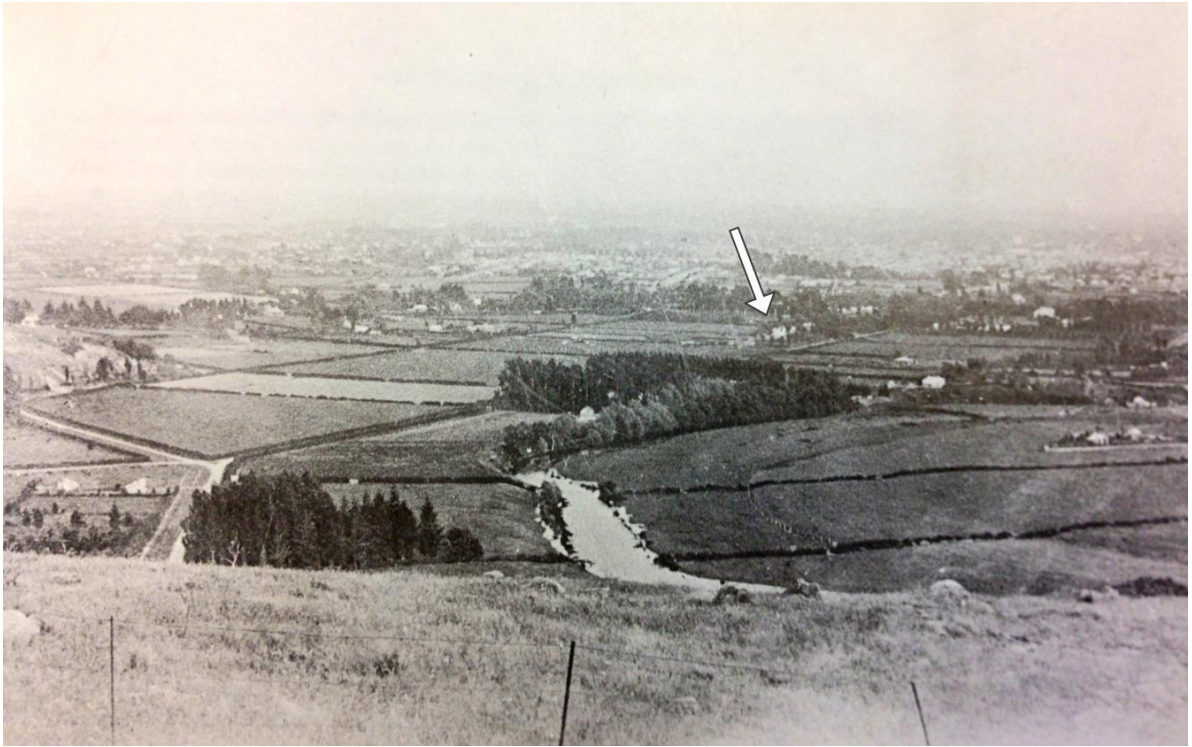
Figure 3.16: Historic photograph of St Martins looking northwest from Murray Aynsley Hill in 1890 overlooking the Centaurus Road - Wilsons Road intersection and Christchurch City in the distance. The Heathcote River can be seen overflowing its banks in the foreground. Surface water is visible across the area coinciding with the location of the paleochannel as marked by the arrow, with the heavily vegetated Heathcote River banks in the background. From Ogilvie, (1991).

Local residents recall the inner bank of the paleochannel being much steeper preceding modification and the building of Cresselly Place prior to the 1960s, and during flooding events the low-lying channel would consistently flood (P. Greening, pers comm, 2015). A historic photo taken from Murray Aynsley Hill in 1890 overlooking St Martins shows the Heathcote River during flood conditions (Fig. 3.16). Surface water can be seen in the location of the paleochannel (arrow on photo) indicating the lowest topography of the point bar surface (Fig. 3.16).

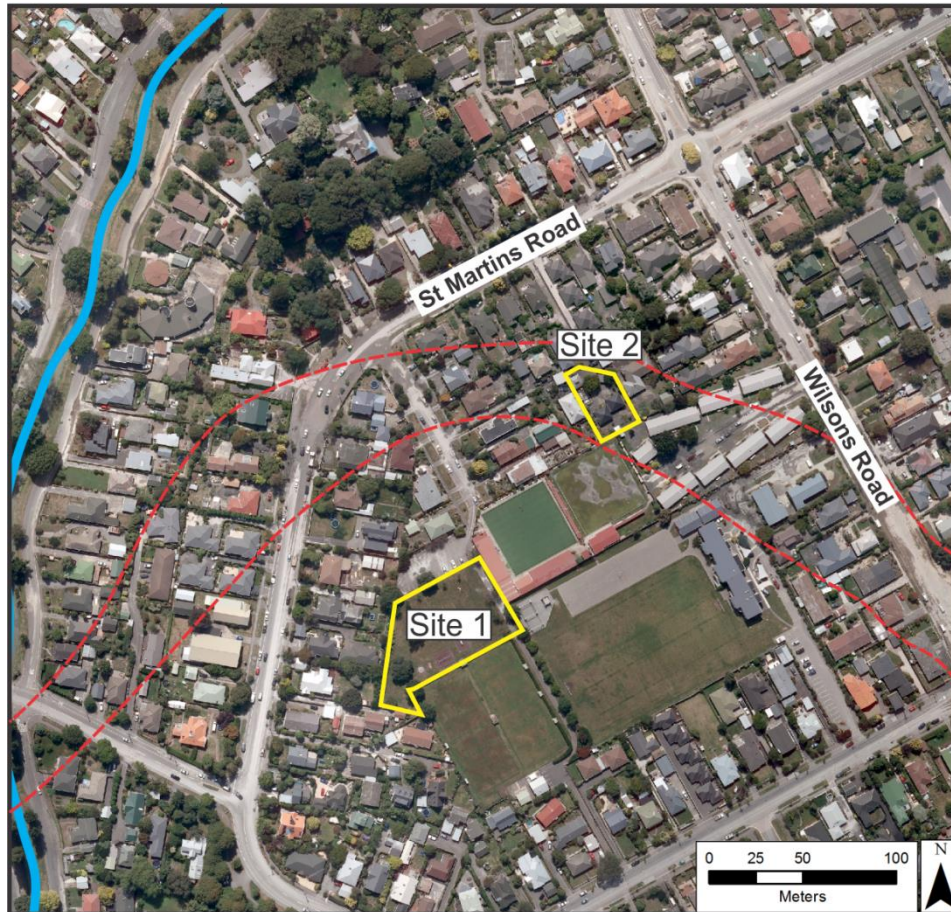
Figure 4.1: Aerial photograph of central St Martins and the locations of Site 1 and 2 (Yellow outline), paleochannel outline from LiDAR and geomorphic mapping (red dashed lines), main roads and the Heathcote River (blue).

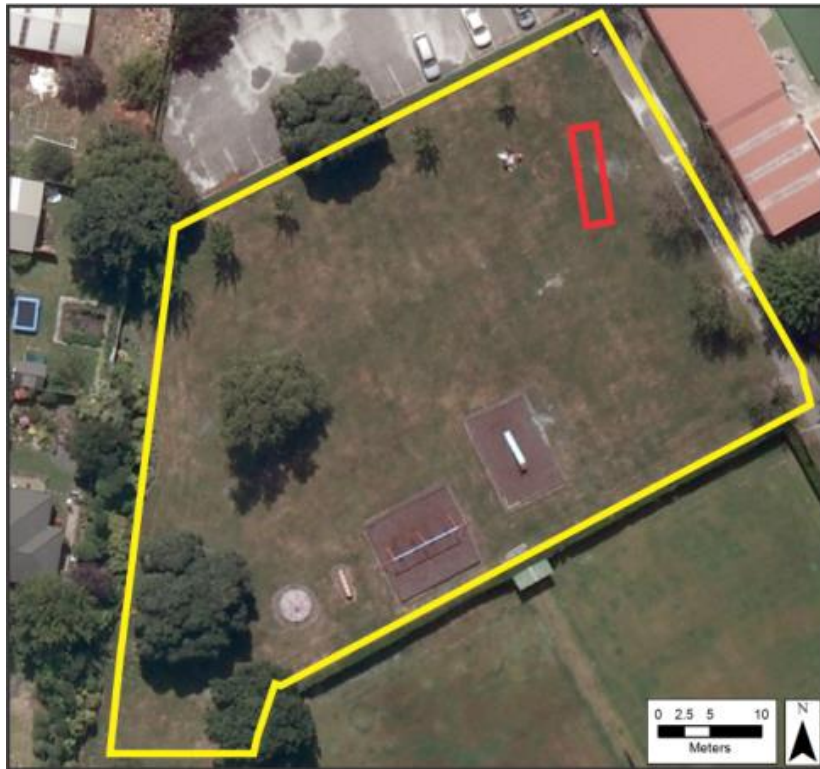
Figure 4.2: Aerial photograph of the Site 1 taken on 24 February 2011 and the location of the trench (Red)

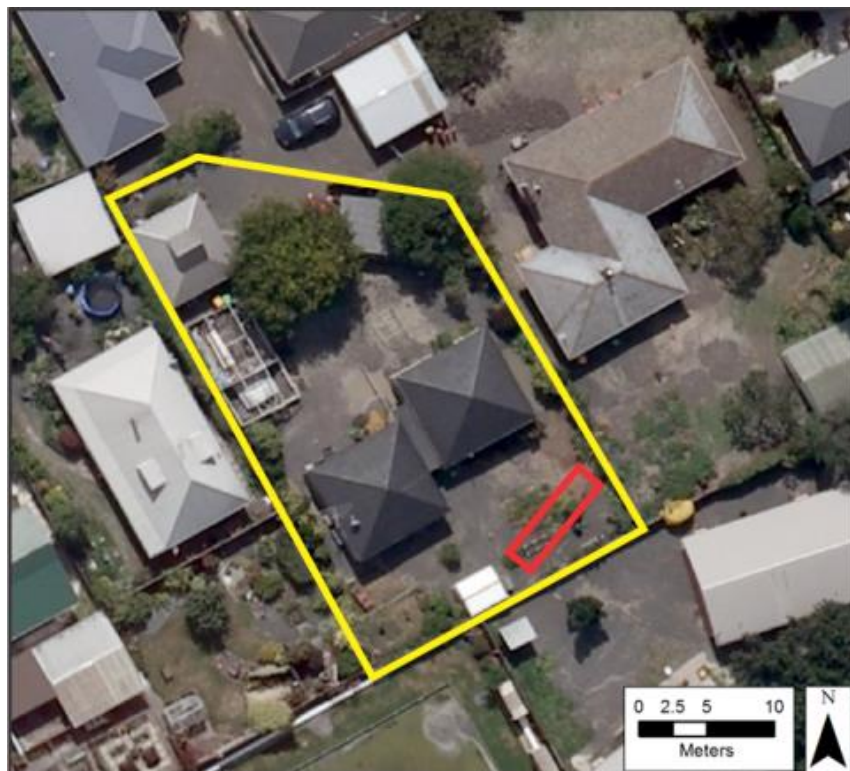
Figure 4.8: Aerial photograph of the Site 2 taken on 24 February 2011 and the location of the trench (Red).

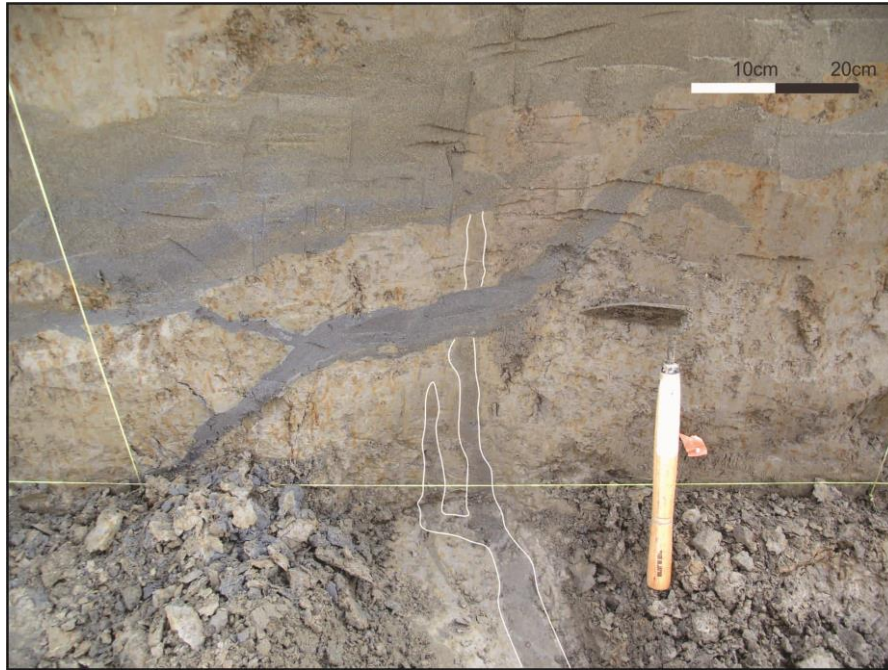
Figure 4.14: Liquefaction sill truncating a subvertical planar dike (outlined in grey). The dike is traceable across the trench floor.

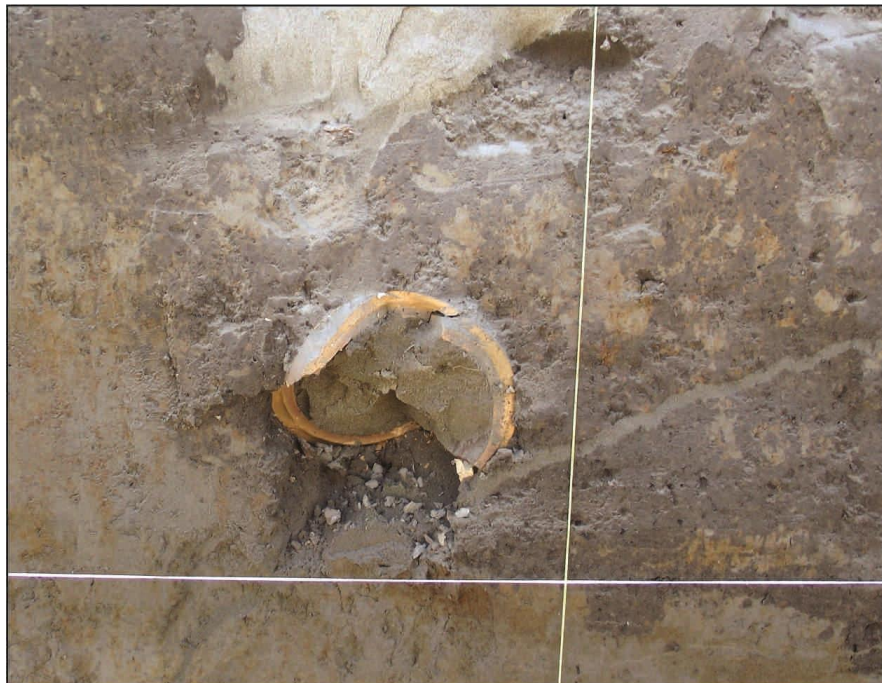
Figure 4.15: Liquefaction-filled clay sewer pipe in the northern end of the trench.

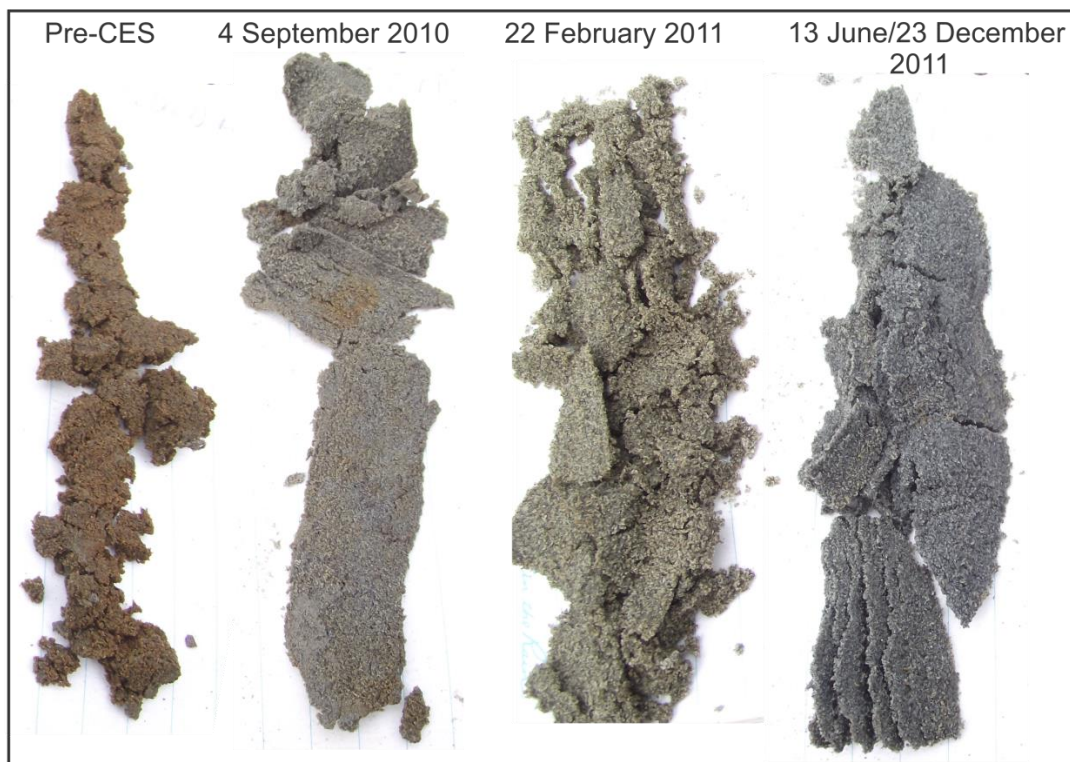
Figure 4.20: Liquefaction deposits collected from Site 2 showing the oxidation and textural differenced of the sediment from individual earthquake events.
